HISTORICAL 6-INCH AND 12-INCH LATERAL PIPES  
INVESTIGATION REPORT

STORMWATER SOURCE CONTROL IMPLEMENTATION

JORGENSEN FORGE FACILITY, SEATTLE, WASHINGTON

December 2010

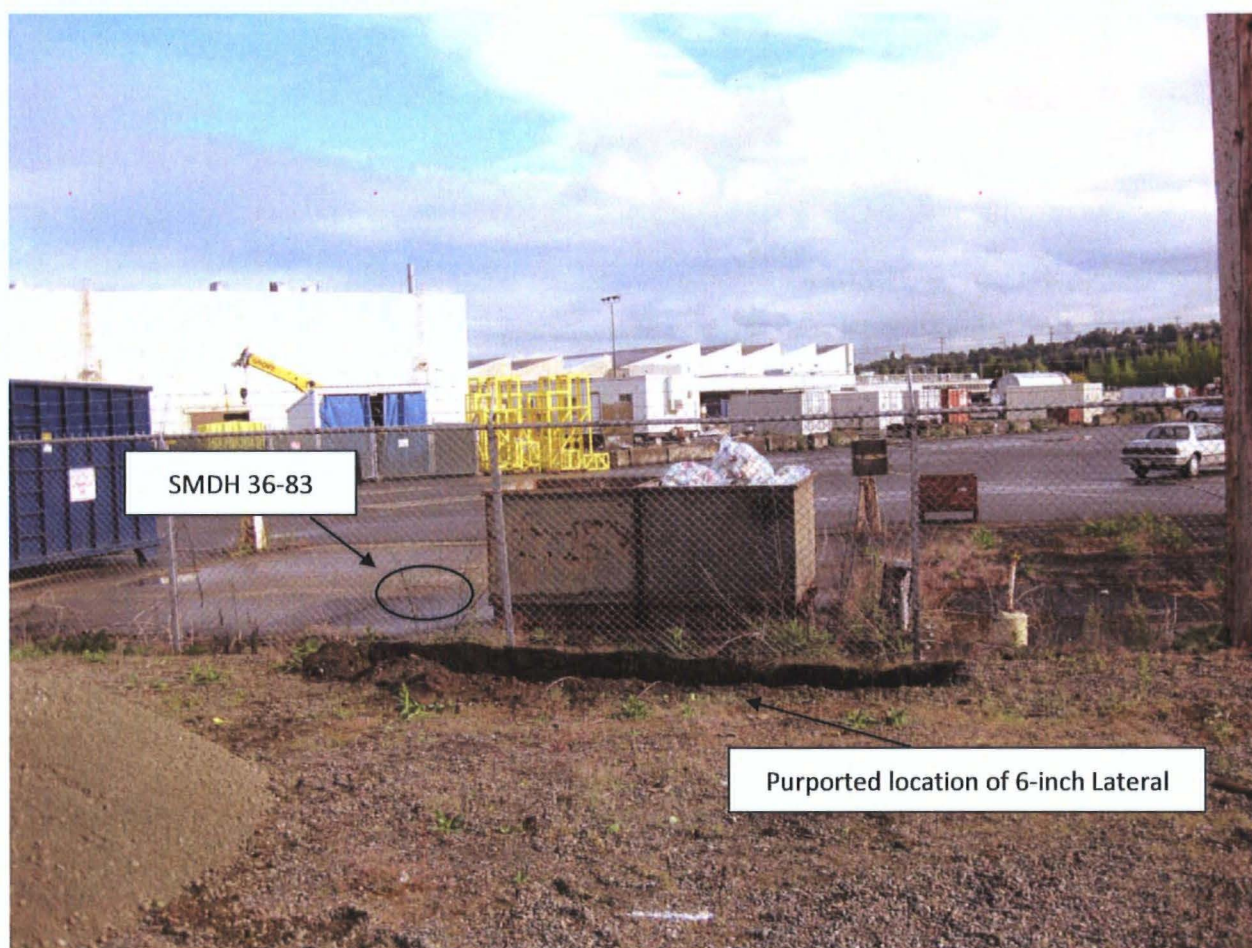
**Photo 1      6-inch Lateral Excavation Facing North toward SMDH 36-83**

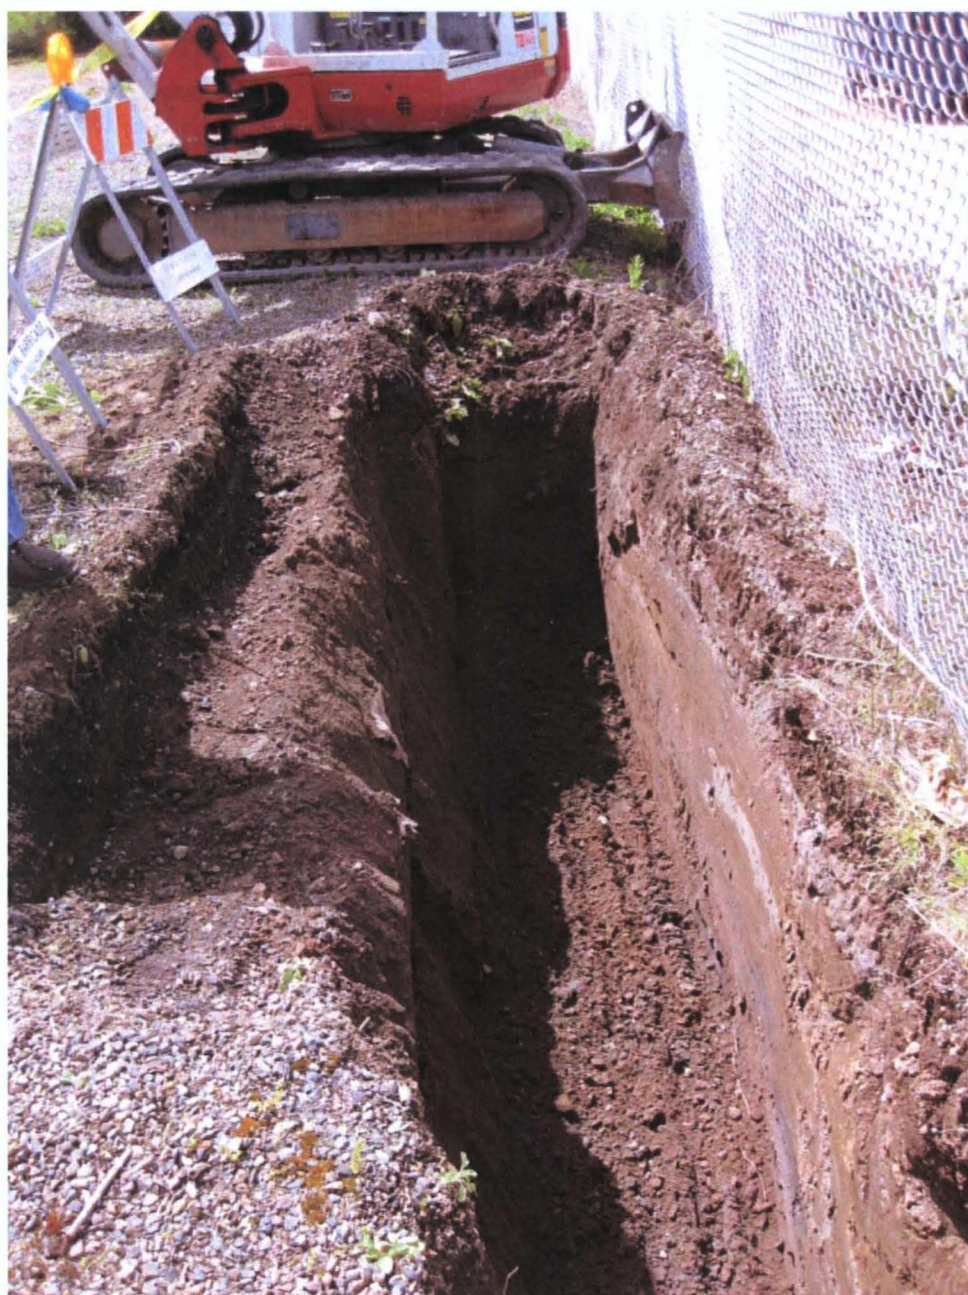
No pipes were identified within the approximately 3-foot-wide by 15-foot-long by 4-foot-deep trench that was excavated along the Jorgensen Forge Property fence line in the area purported to contain the 6-inch Lateral at approximately 20 inches below ground surface (see *Phase 2 Transformer PCB Investigation Report* [Floyd | Snider and Weston Solutions 2005]).

**Photo 2      6-inch Lateral Excavation North Wall Showing No Pipe**

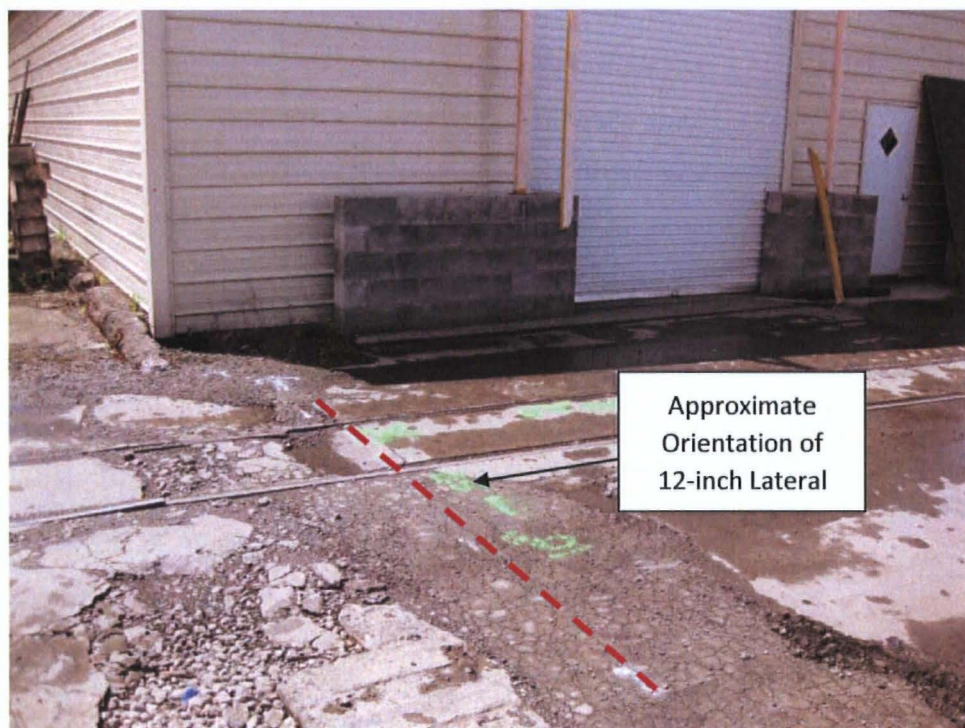
**Photo 3**      **12-inch Lateral Location Point**

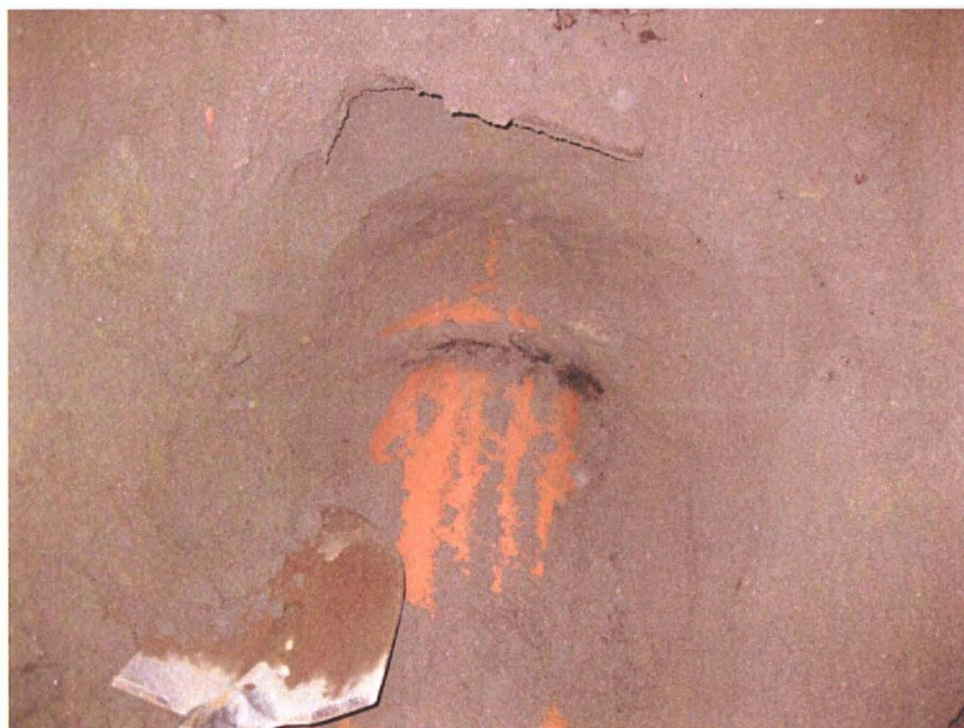
The laboratory analytical results of the two solids samples collected from the gasket material within the bell of the 12-inch Lateral were inconsistent and detected concentrations of Total PCBs at 260 mg/kg and 0.29 mg/kg (Table 1). A review of the laboratory documentation did not explain the variability between the reported concentrations.

**Photo 4**      **12-inch Lateral Bell Location (Gasket Sampling Location)**

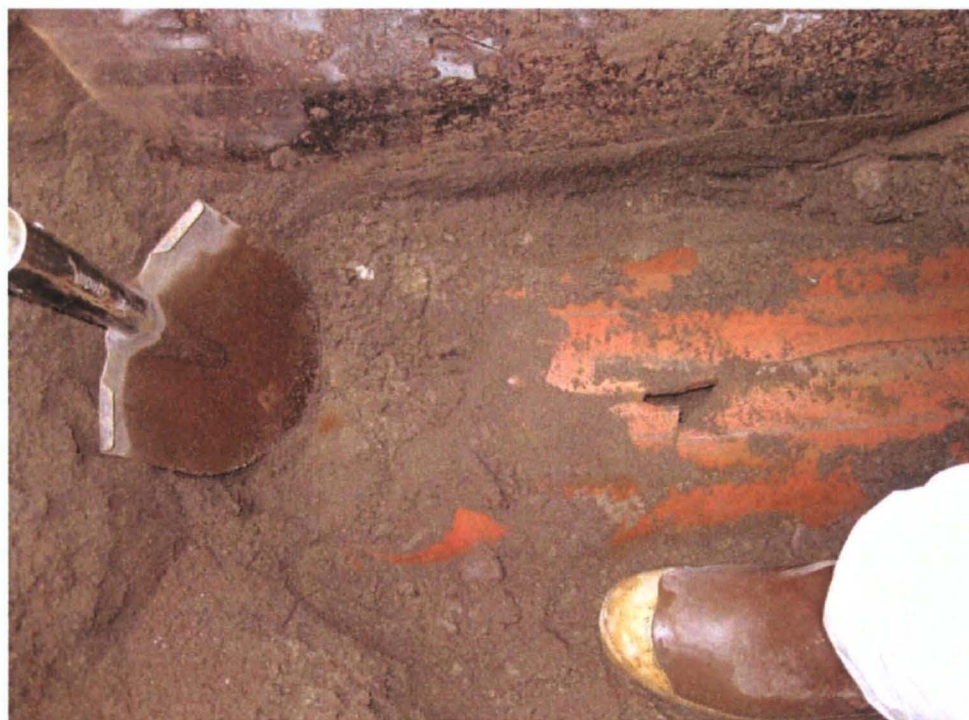
Soil was then removed by shovel from the south end of Excavation Area #2 to expose the 12-inch Lateral termination point. This exposed an area where the top of the 12-inch Lateral was cracked (Photo 5) adjacent to a grout and soil plug (Photo 6). The soil type encountered was consistent with the surrounding and overlying soil type. A single soil sample was collected from just above the Lateral and submitted for analysis of total solids, TOC, metals, PCBs, and PAHs. To the extent possible without undermining the overlying building,

**Photo 5**      **12-inch Lateral Termination Point**

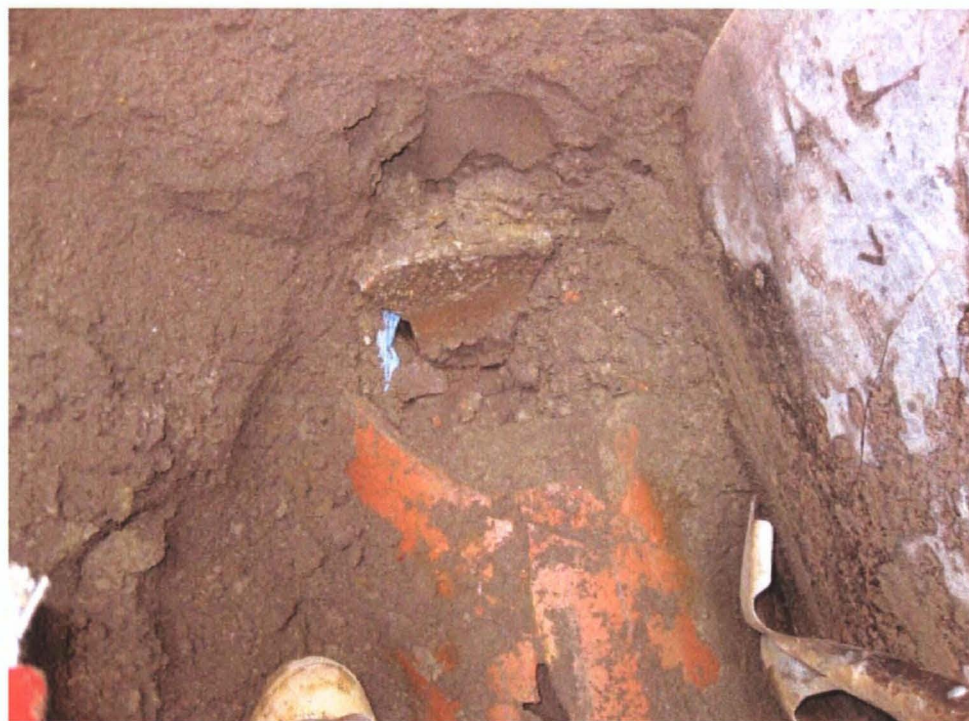
**Photo 6**      **12-inch Lateral Termination Point Grout and Soil Plug**

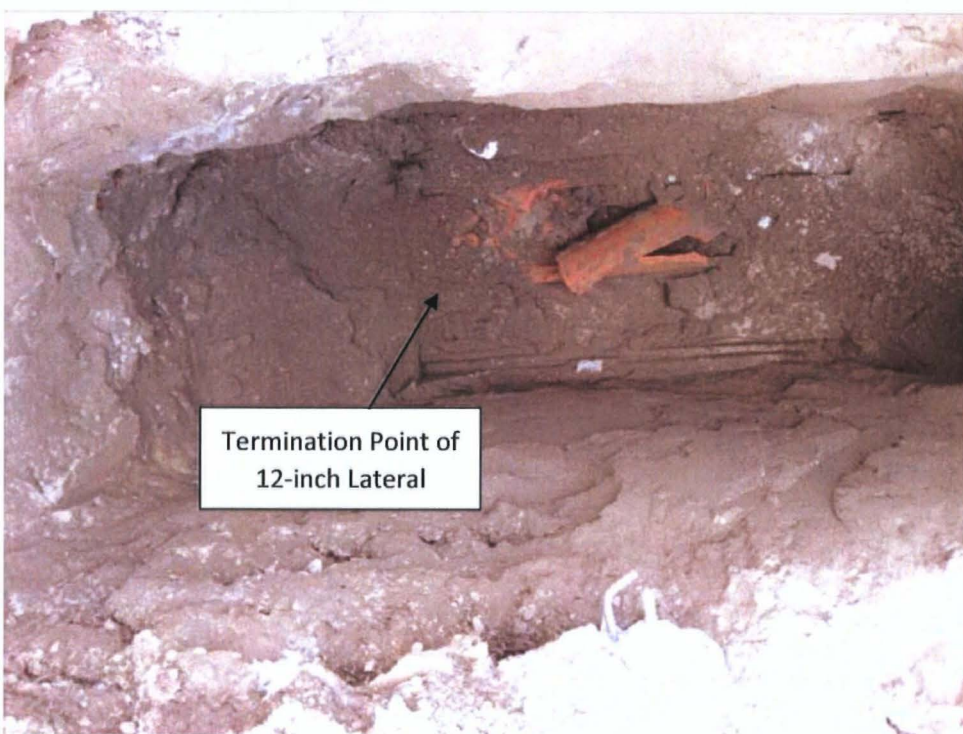
additional soil was excavated several feet to the south of the plug to determine if the 12-inch Lateral re-initiated further upgradient (Photo 7). No additional pipe was observed indicating the grout and soil plug was the termination point of the 12-inch Lateral. This location is approximately 18 inches west (outside) of the remnant stub wall (Photo 8) from the former Bethlehem Steel Facility building visible in aerial photographs, providing evidence that the 12-inch Lateral did not enter that building. The bottom interior of the Lateral was measured to be 6.8 feet below ground surface, as measured from the adjacent concrete slab. PLS, Inc., surveyed the adjacent slab locations (Appendix B); the bottom of the Lateral pipe's elevation is 13.76 feet MLLW. The aerial extents of the Excavation Area #2 are shown in Photo 8.

**Photo 7      12-inch Lateral South Excavation Extent**

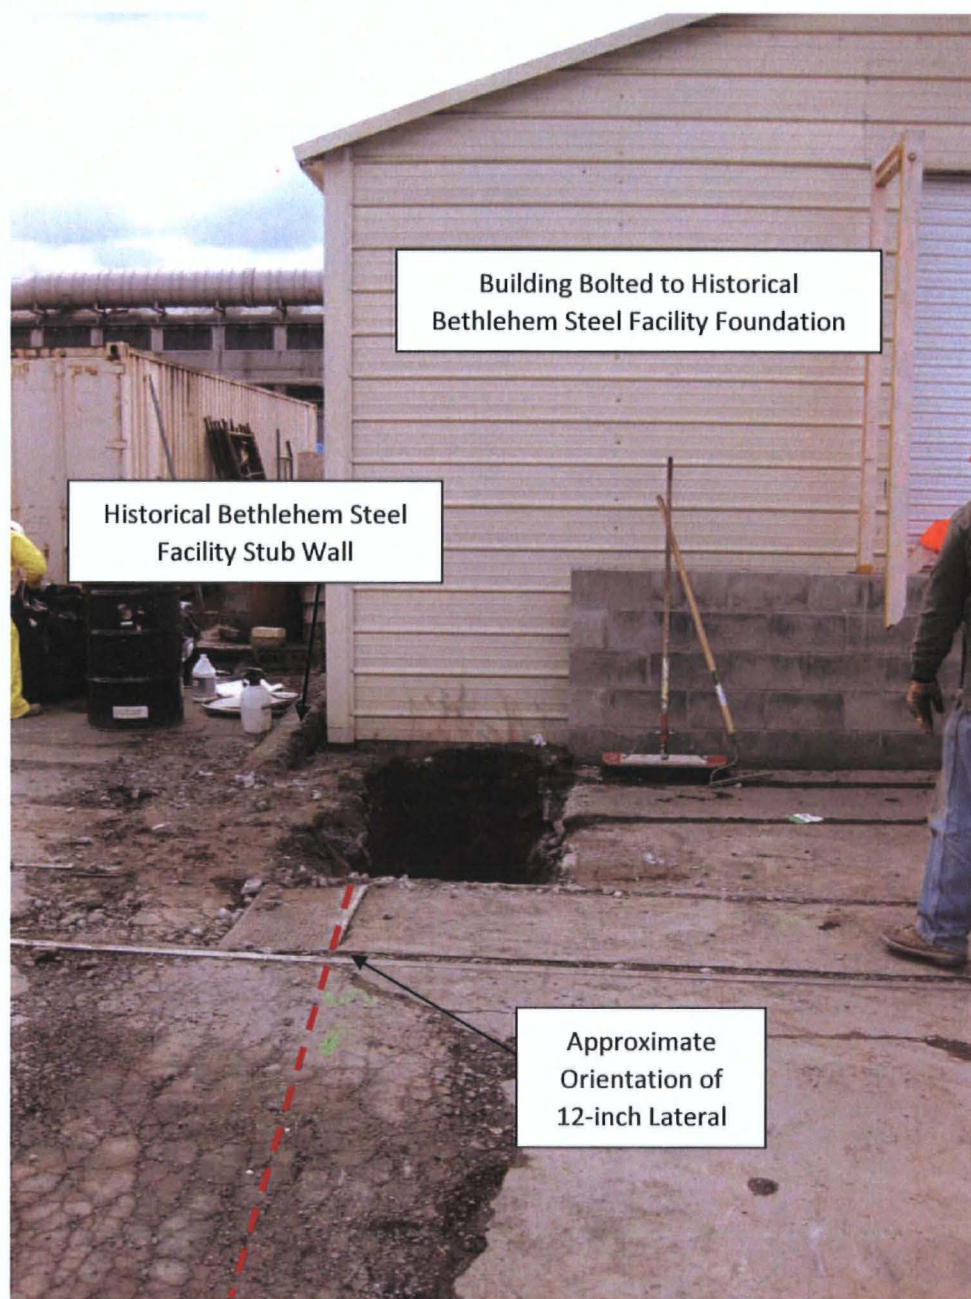
**Photo 8**      **12-inch Lateral Topside Excavation Extent**

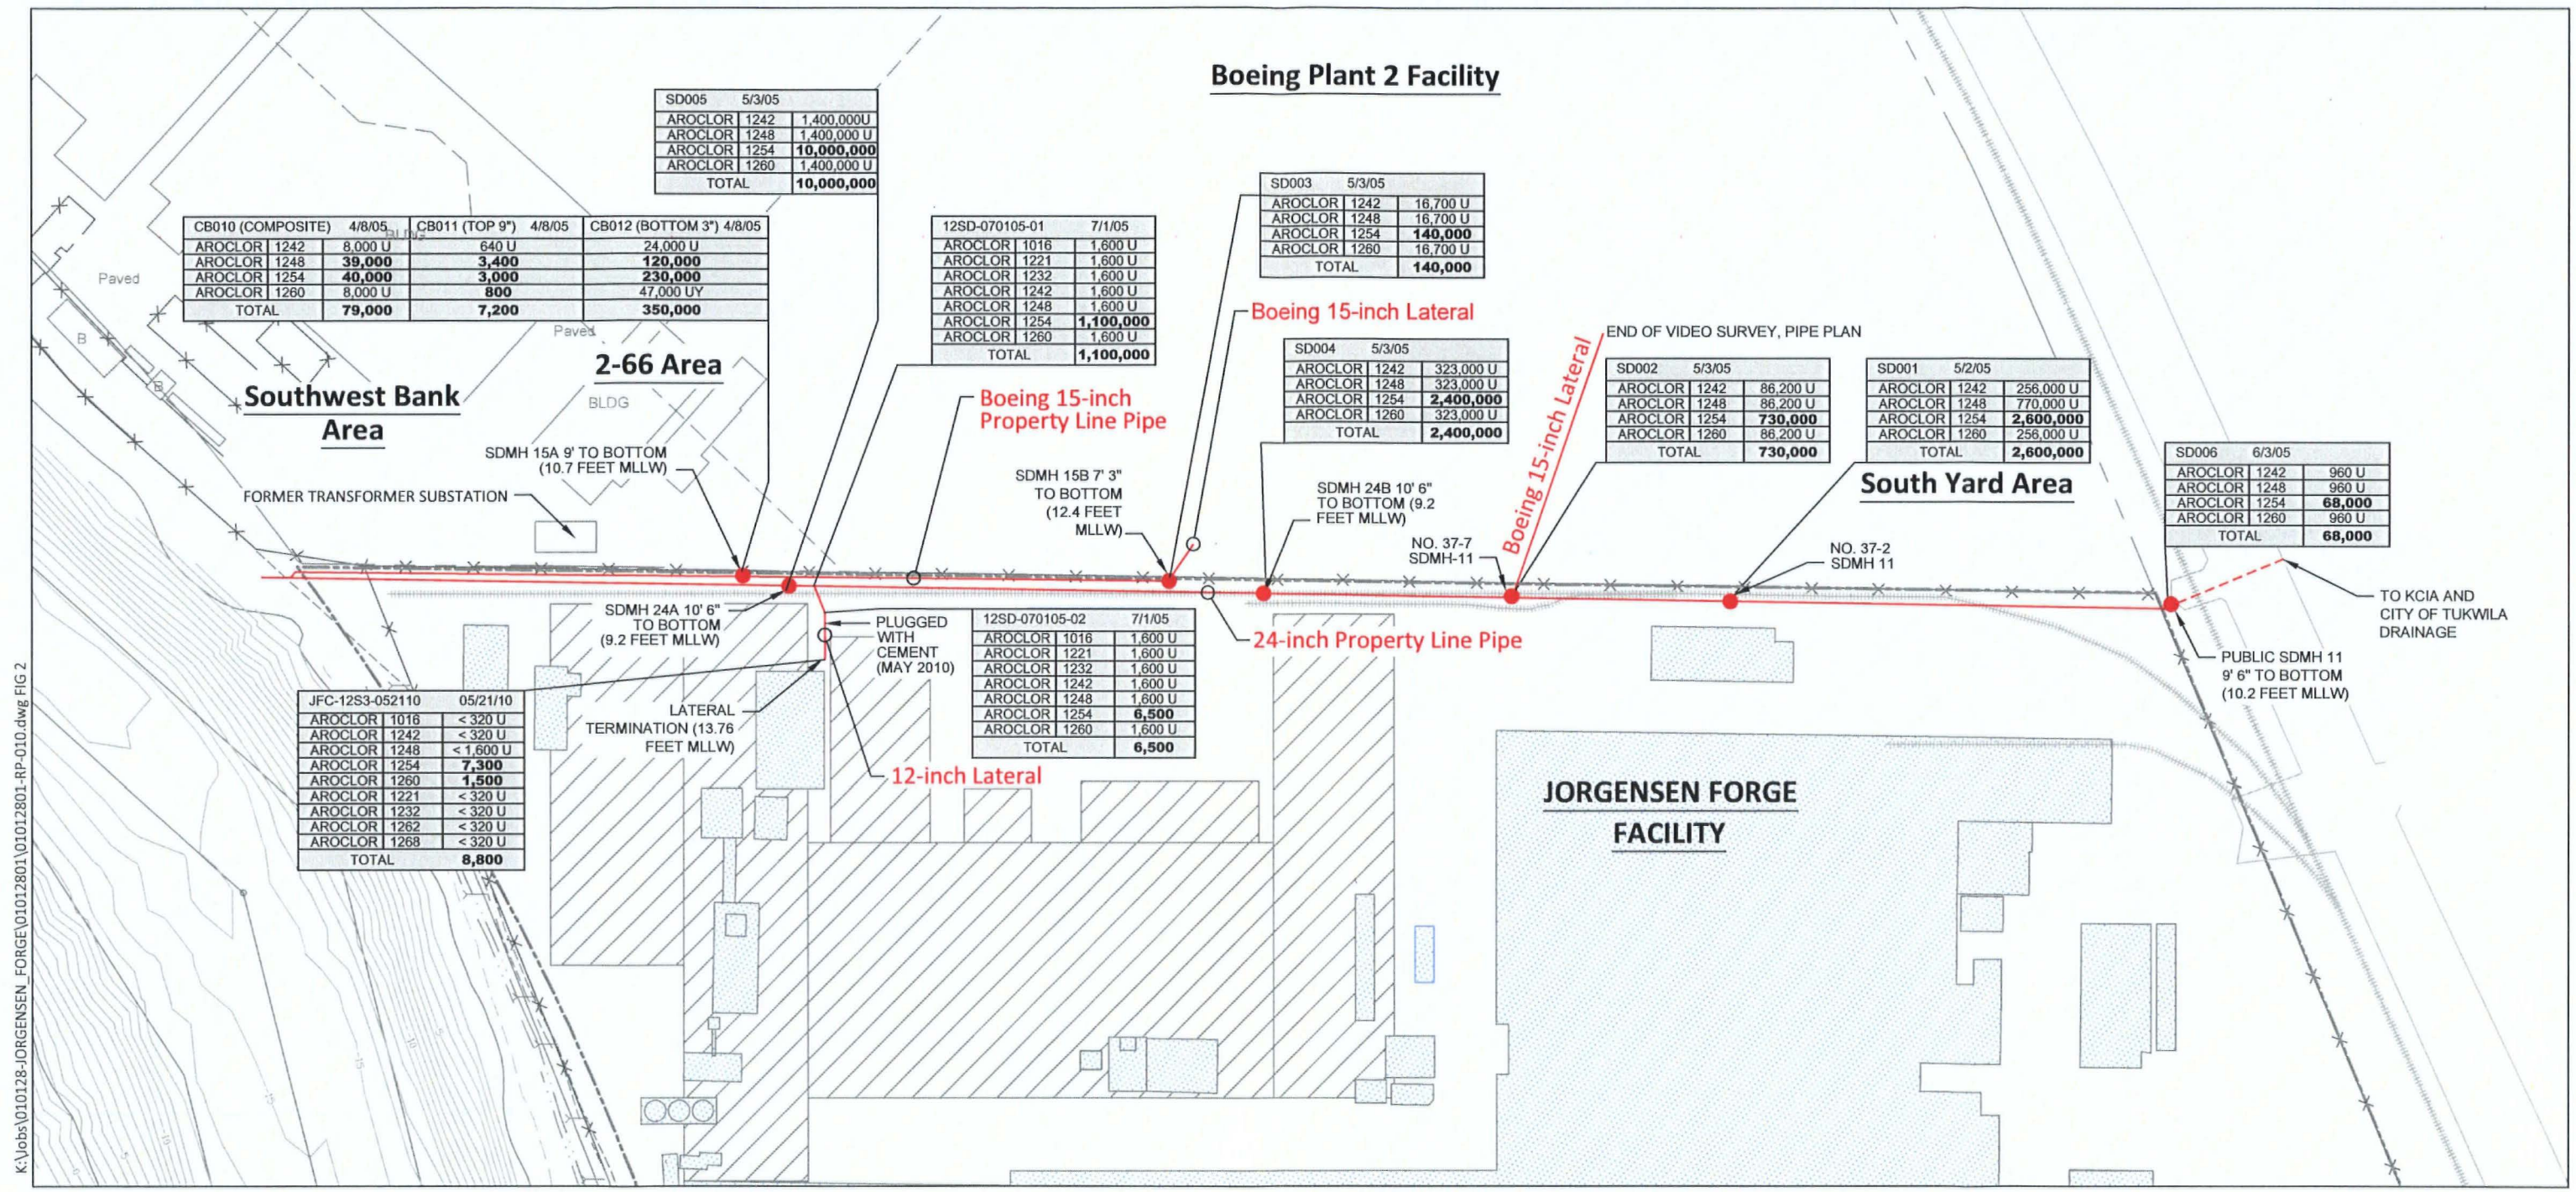
**Figure 2**  
Property Line Pipes PCB Analytical Results  
6-inch and 12-inch Lateral Property Line Pipe Investigation  
Jorgensen Forge Corporation  
8531 East Marginal Way South, Seattle, Washington

The sample results for the various collected samples are summarized in Table 1 and visually represented in Figure 2. The video reconnaissance findings are included in Appendix A.

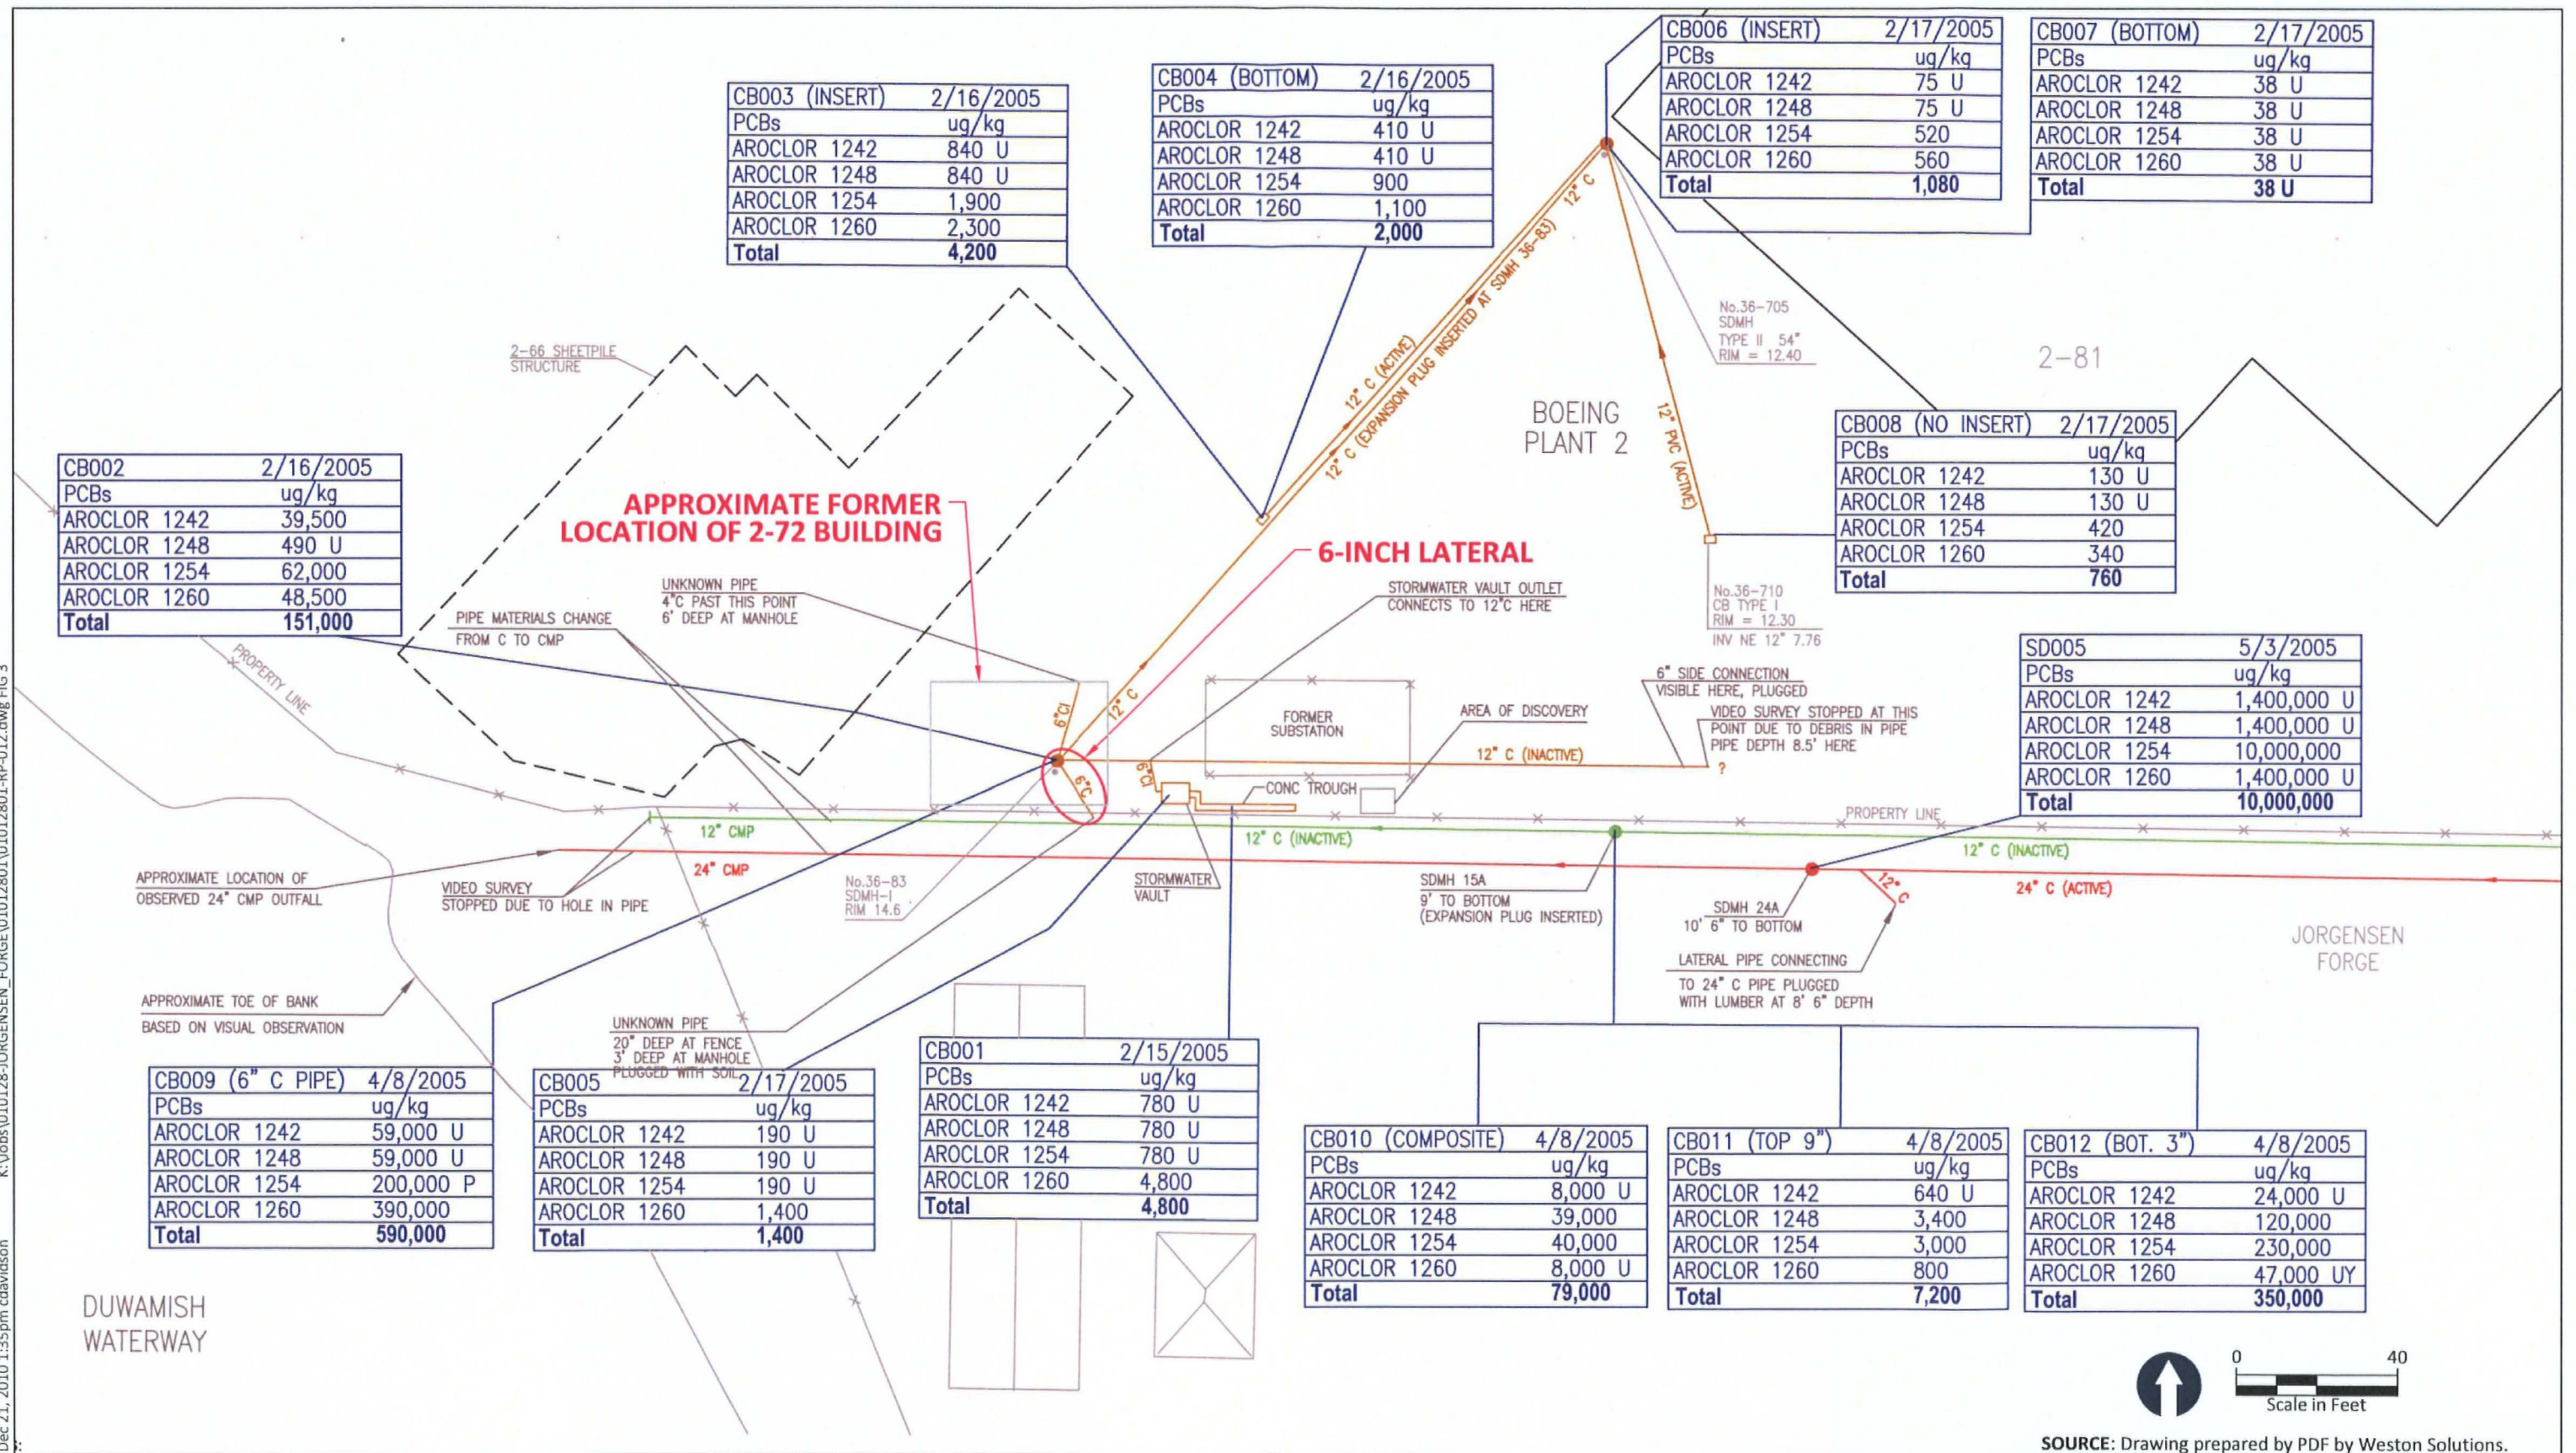
Figure 3.7 of *Phase 2 Transformer Investigation Report* (reproduced as Figure 3 of this Investigation Report) displays all of the PCB concentrations and shows that the 6-inch Lateral was located at 20 inches below ground surface on Plant 2, just north of the Jorgensen Forge Property line.

Following completion of the *Phase 2 Transformer Investigation Report* (Floyd | Snider and Weston Solutions 2005), Anchor QEA, LLC, conducted a review of aerial photographs dating from initial operations at the Jorgensen Forge Property in the mid-1940s to the present. Throughout this period, there were no structures on the Jorgensen Forge Property in close proximity to the area where the 6-inch Lateral terminated on Plant 2. Alternatively, Building 2-72 was located on Plant 2 in the direct vicinity of the termination location and could have contributed discharges to the 6-inch Lateral (Figure 3).

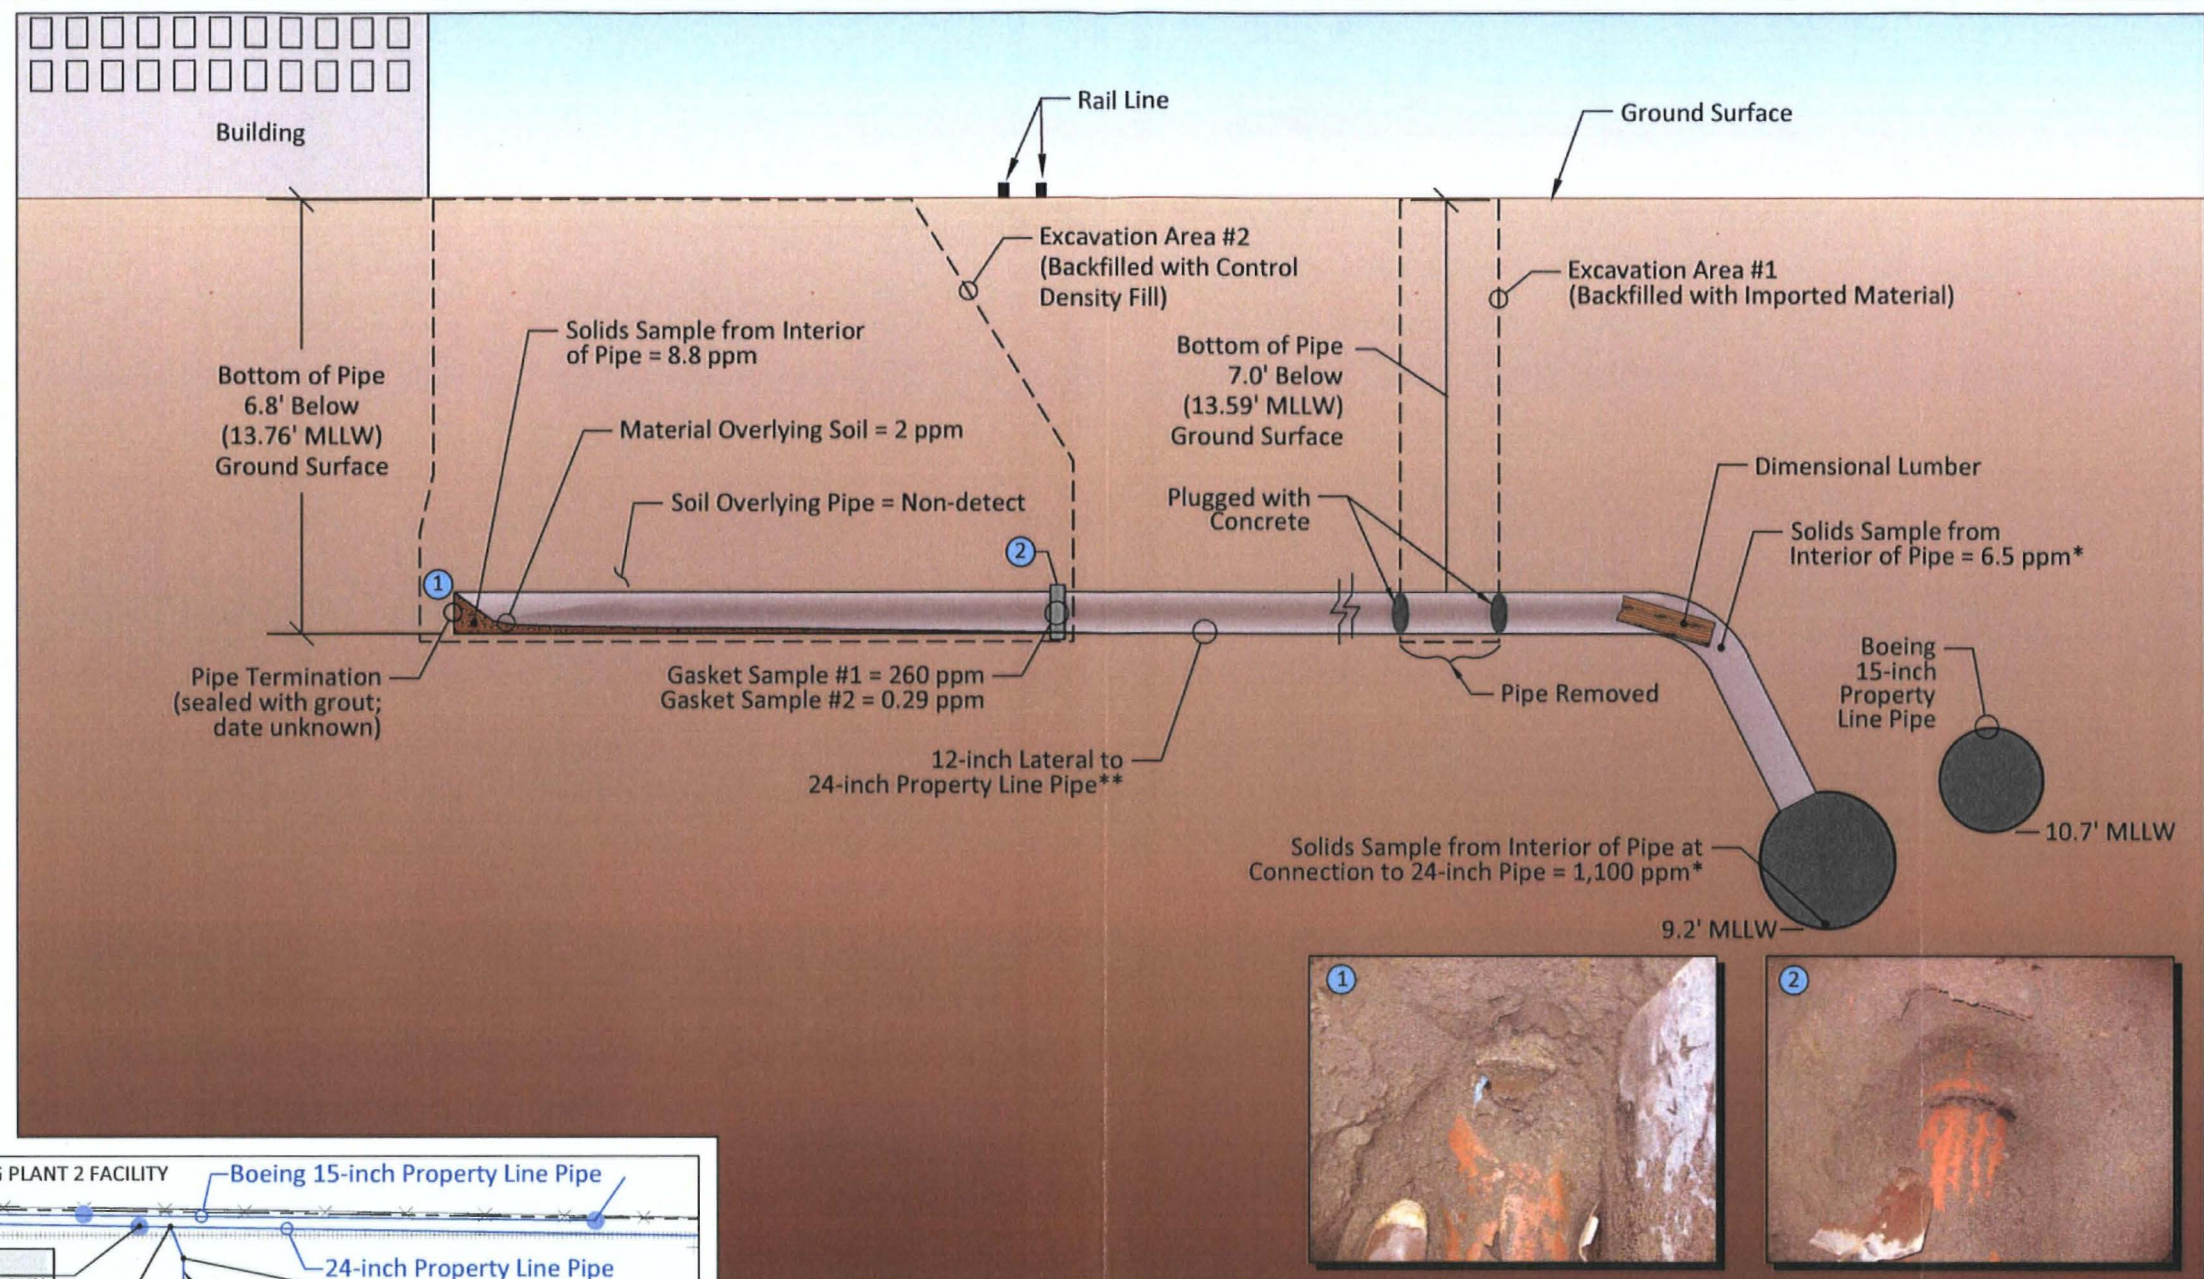
As shown in Figure 4, the concentrations of Total PCBs detected within the inert gasket material within the 12-inch Lateral (0.29 mg/kg) are significantly lower than the concentrations identified near the connection to the 24-inch Pipe (1,100 mg/kg) and at the nearest downgradient sample within the 24-inch Pipe (10,000 mg/kg). Based on the location of the stub wall and a review of historical aerial photographs, the 12-inch Lateral is located outside of the former Bethlehem Steel Facility buildings. Additionally, the 12-inch Lateral was not shown to extend further south of the termination point. These findings are consistent with a pipe that would have served as a roof drain or catch basin outside of the adjacent buildings.
